SUBJECT: CLEAN AIR ACT INSPECTION REPORT
DP&L Killen Station- Manchester, Ohio

Facility: The Dayton Power and Light Company (DP&L) Killen Station

Date of Inspection: October 1, 2014

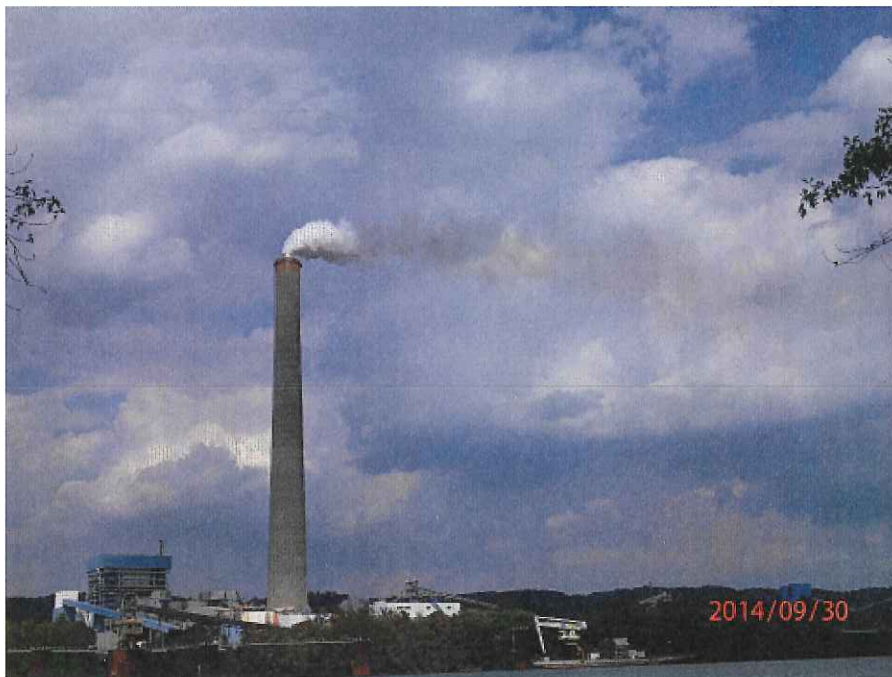
Mr. Stice asked what triggered the inspection. EPA informed Mr. Stice that a secondary plume and visible emissions were seen on September 30, 2014 (Figure 1) and as EPA inspectors were driving up to the facility. Mr. Stice proceeded to review a list of questions he was required to ask when such an inspection takes place. EPA explained that it noticed a trend of increasing nitrogen oxide (NO_x) and sulfur dioxide (SO₂) emissions in the Clean Air Markets reported data and was concerned. Mr. Stice indicated that the assistant plant manager would be joining the meeting and that JoAnne Rau from the corporate office in Dayton, Ohio was driving down to join as well. EPA then asked Mr. Stice for an overview of the facility and then a tour of the facility, specifically looking at the pollution control equipment. Steven Barnoski, assistant plant manager, joined the meeting at 9:57 AM after driving from the DP&L Stuart Station nearby.

**Figure 1 Secondary plume from Killen Station stack
(Viewed from south side of Ohio River in Kentucky)**

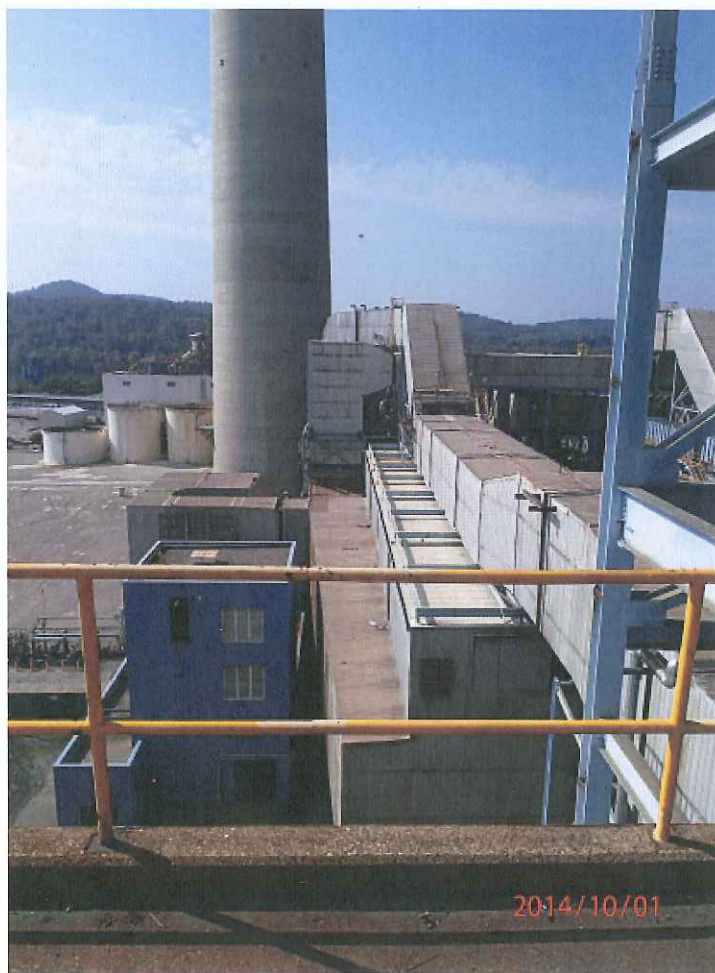
Mr. Stice began going through the presentation on operations focusing on the pollution control equipment, specifically the electrostatic precipitator (ESP), the selective catalytic reduction (SCR), and the flue gas desulfurization scrubber (FGD) (Figure 2). The boiler is fired on #2 fuel oil at start up because the ESP needs to get up to temperature in order to operate efficiently. After the temperature reaches 200°F, the boiler is switched over to coal. Coal is not fired in the boiler until the ESP is up to temperature and operating. There are additional safety concerns if the boiler was fired on coal during start up. The ESP is on the hot side of the air exchanger (pre-heater).

Figure 2 East ductwork (ESP housing and SCR shown)

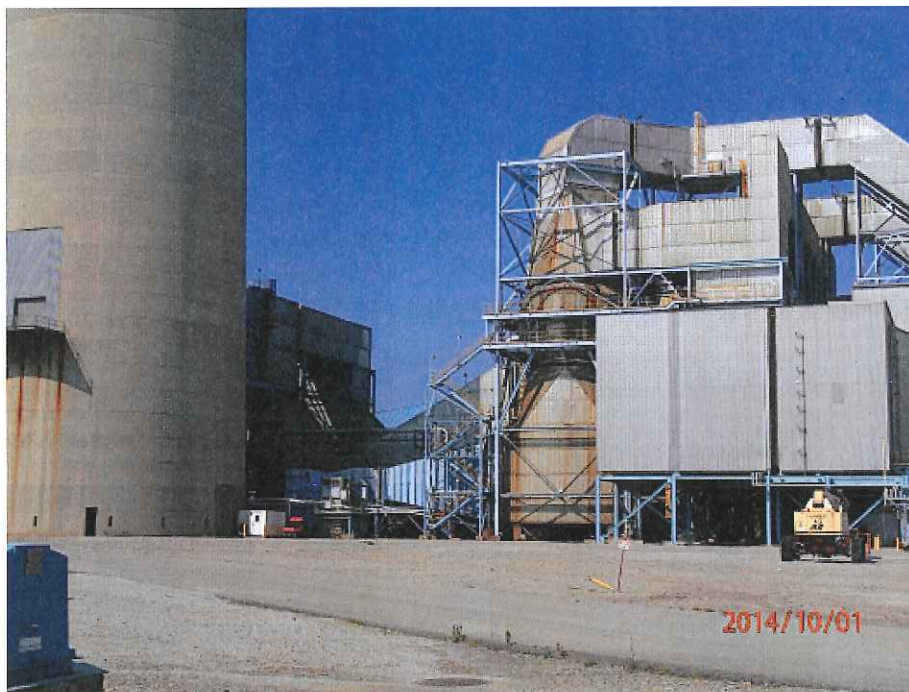
The SCR was installed in 2004 purely for the NO_x credits under NO_x SIP call. The SCR is a horizontal flow type SCR (Figure 3). Upon exiting the boiler, the ductwork splits into two different paths, East and West, before combining again prior to the FGD. The SCR uses ammonia injection and cycled 6 months in service and 6 months out of service. The system is equipped with a bypass and is used when the system is out of service. It costs more to operate the SCR in ammonia usage than is earned in credits on the Clear Air Markets. There is a minimum temperature for operation of the SCR such that the SCR is bypassed during startup to prevent potential ammonia slip. Ammonia injection is monitored by computers to

protect catalyst life and prevent ammonia slip from occurring. The catalyst layers are carefully monitored to ensure maximum catalyst life and reduce costs.

Figure 3 SCR Unit East (middle structure with rust coloring) and CEMS building (white building near base of stack)

After the walk-through with Mr. Keith, Mr. Stice and Ms. Rau led a tour to see the continuous emissions monitoring system (CEMS) building (Figure 3) and FGD. The Killen has CEMS for SO₂, NO_x, PM and CO₂. The CEMS probes are located at 450 feet up the stack, which has a total height of 900 feet. During the inspection the CEMS were reading 0.449 lbs SO₂ per MMBtu (on a 3-hour average) and 0.540 lbs NO_x per MMBtu (on a 3-hour average). Ms. Rau indicated that in order to be in compliance with the Mercury and Air Toxics Standards (MATS) in April 2015, the SCR will need to run constantly. There is no planned additional construction to meet the MATS.

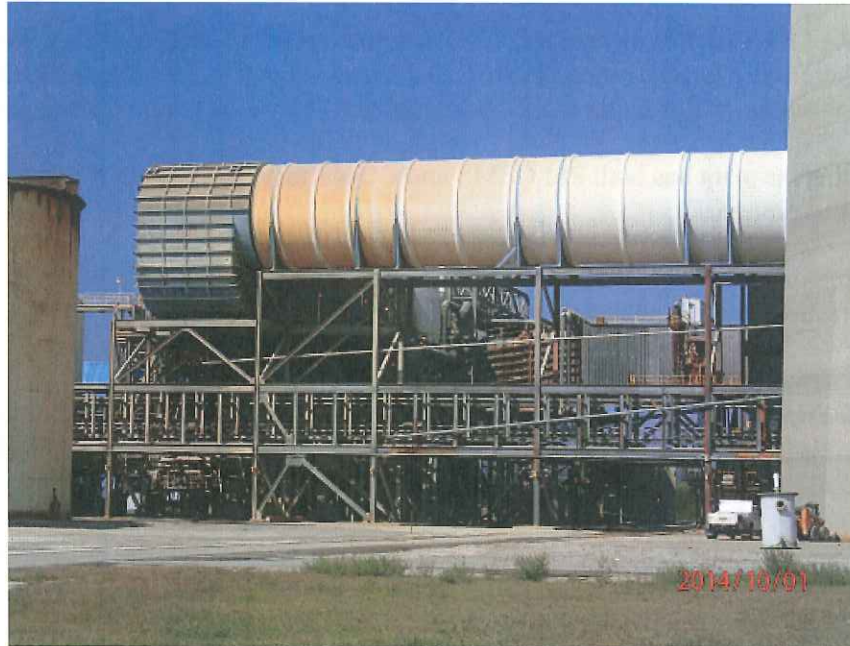
The FGD (Figure 4) was installed for SO₂ credits in 2007 at a cost of around \$860 million and has been used since the switch from “compliance” coal to Illinois Basin coal. The FGD is a Chiyoda manufactured jet bubble reactor that holds 1.3 million gallons of limestone slurry. There is a small restriction bypass that allows up to 30% of the exhaust stream to bypass the FGD and exit through the stack. From 2008 to present day, the FGD is getting about 93% SO₂ removal. Killen is required to run the FGD at all times since the plant is now burning a high sulfur, Illinois basin coal and must show compliance with the Unit’s 1.2 lbs/MMBtu SO₂ NSPS limit.

Figure 4 FGD Unit (outlet duct seen in foreground)

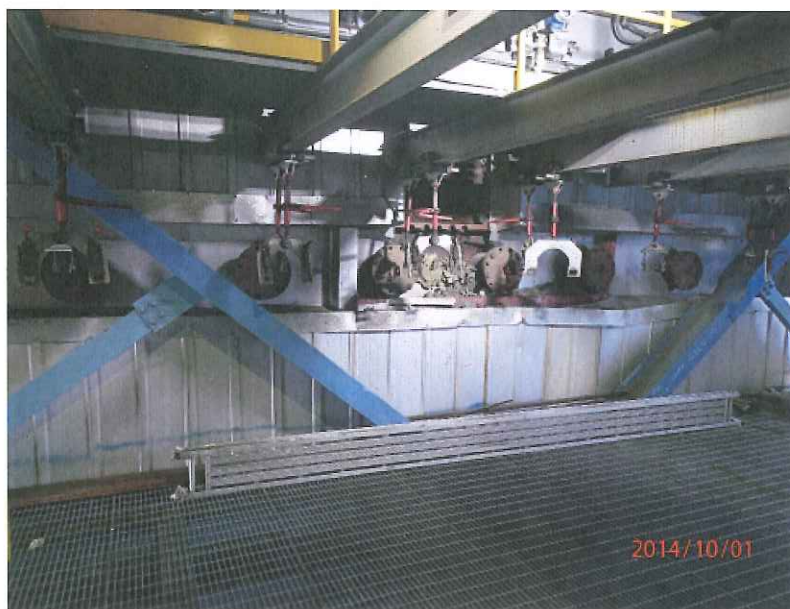
Mr. Stice indicated that a SBS system was recently installed at both the Killen (Figure 5) and Stuart stations to control sulfuric trioxide (SO_3) emissions that were corroding the ductwork downstream of the SCR. Mr. Stice indicated that the SBS systems were installed for operational reasons, not environmental and are very costly to operate. Neither of the SBS systems are currently running however due to “operational issues”. The SBS system at Killen uses soda ash injection at two locations, at the economizer and at the inlet of the secondary air. DP&L had problems with the injections lances at Killen and was forced to remove the lances and ship them to Texas for refurbishment. The lances are projected to be back from Texas and in service date by December 2014. The SBS system at Stuart was determined to be “unmanageable” and has no projected in service date. Mr. Stice was unaware of any permits obtained for the SBS system installations.

Figure 5 Location of SBS system (not currently in place)
